Manhole Inspection Summary

Manhole # S21GG_022MH

Insp Date: **3/17/09 1:33 PM**

Location Address: **1448 MOUNT ST**

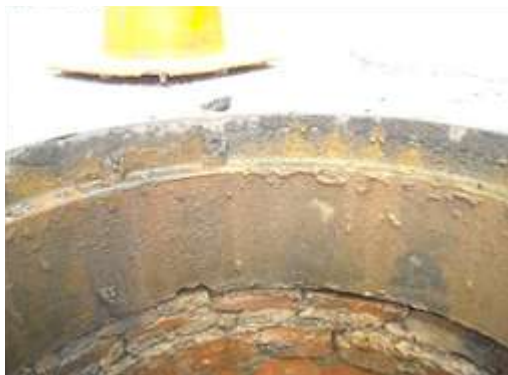
Subject To Ponding: **Sheeting**

EVIDENCE OF INFILTRATION DUE TO
SHEETING FROM ROADWAY

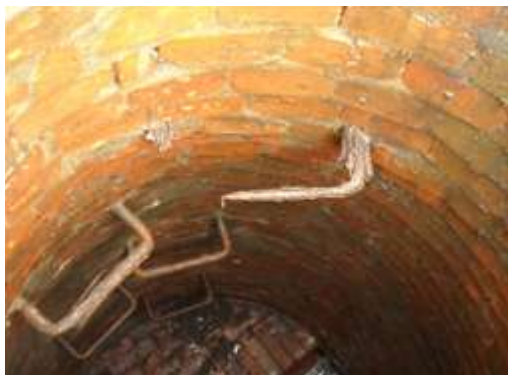
Defect 2

Count: **5** Missing: **0** ☒ **Corroded**

CORRODED STEPS

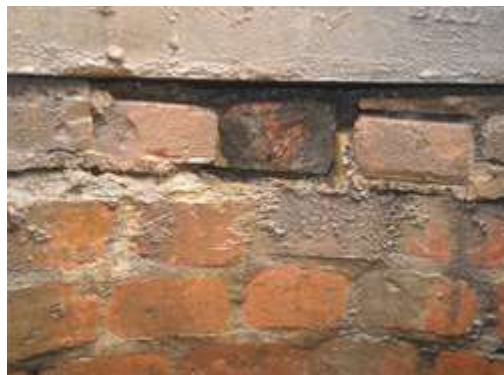
Defect 1

Condition: ☐ Sound ☐ Cracked ☐ Root Intrusion ☒ **Loose Brick** ☒ **Deteriorated**

MISSING BRICK IN CHIMNEY
ADJUSTMENT

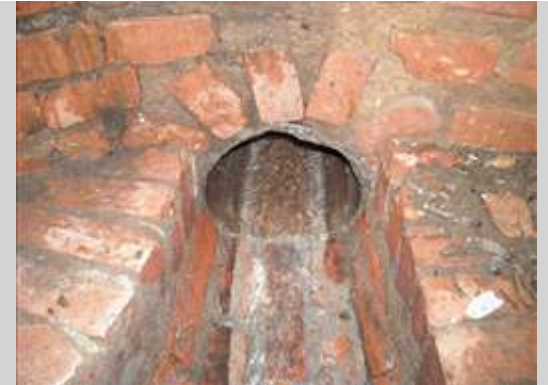
12 O'Clock Outflow

Pipe Height: **8.4** (in.) Rod and Bar (Angled)
Pipe Material: **Clay** ☐ Pipe Lined
Invert Depth: **9.42** (ft.) Flow Characteristics: **Slow**
Deposits: ☒ None ☐ Mud ☐ Sludge ☐ Debris ☐ Grease
Silt Depth: (in.) Deposits Extent:
Infiltration: **None** Pipe Seal Cond: **Sound**

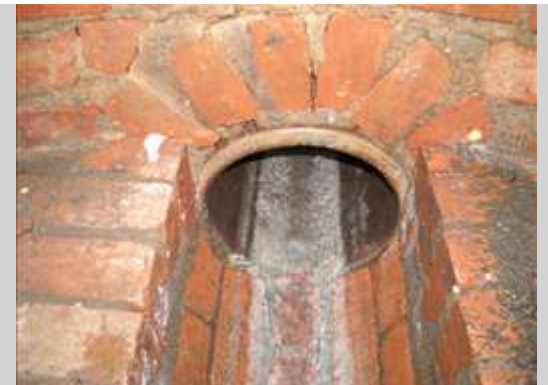
6 O'Clock Inflow

Pipe Height: **8.4** (in.) Rod and Bar (Angled)
Pipe Material: **Clay** ☐ Pipe Lined
Invert Depth: **9.31** (ft.) Flow Characteristics: **Slow**
Deposits: ☒ None ☐ Mud ☐ Sludge ☐ Debris ☐ Grease
Silt Depth: (in.) Deposits Extent:
Infiltration: **None** Pipe Seal Cond: **Sound**

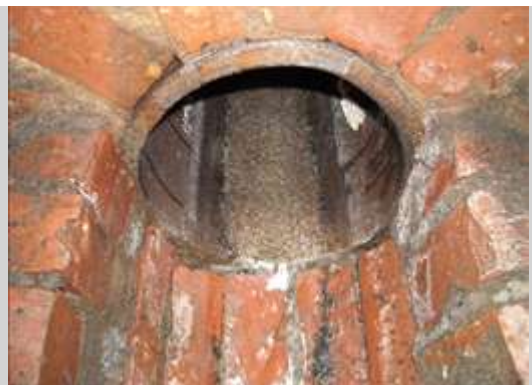
9 O'Clock Inflow

Pipe Height: **8.4** (in.) Rod and Bar (Angled)

Pipe Material: **Clay** ☐ Pipe Lined

Invert Depth: **9.00** (ft.) Flow Characteristics: **Slow**

Deposits: ☒ None ☐ Mud ☐ Sludge ☐ Debris ☐ Grease

Infiltration: **None** Pipe Seal Cond: **Sound**
